## CAPACITY BUILDING PROGRAM FOR SUSTAINABLE RECONSTRUCTION - REBUILD

### Deliverable 4.5

#### Report Study visit in Georgia

## 1. Rehabilitation and Restoration of the State Silk Museum, a Cultural Heritage Monument

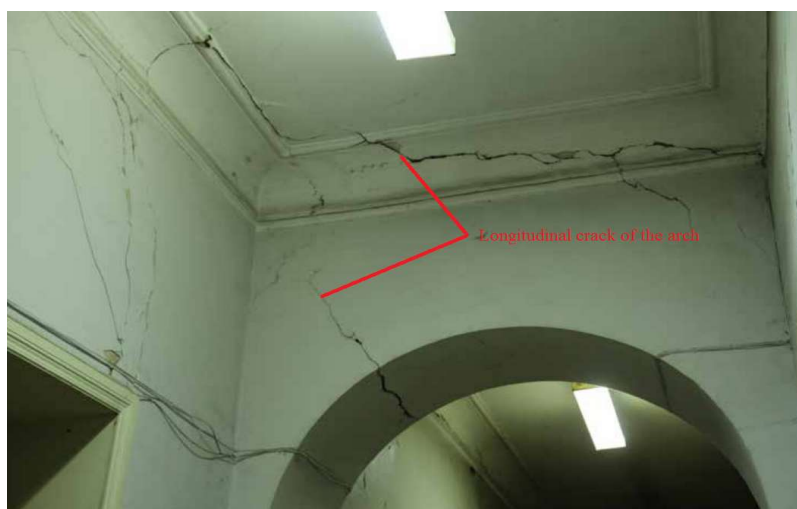
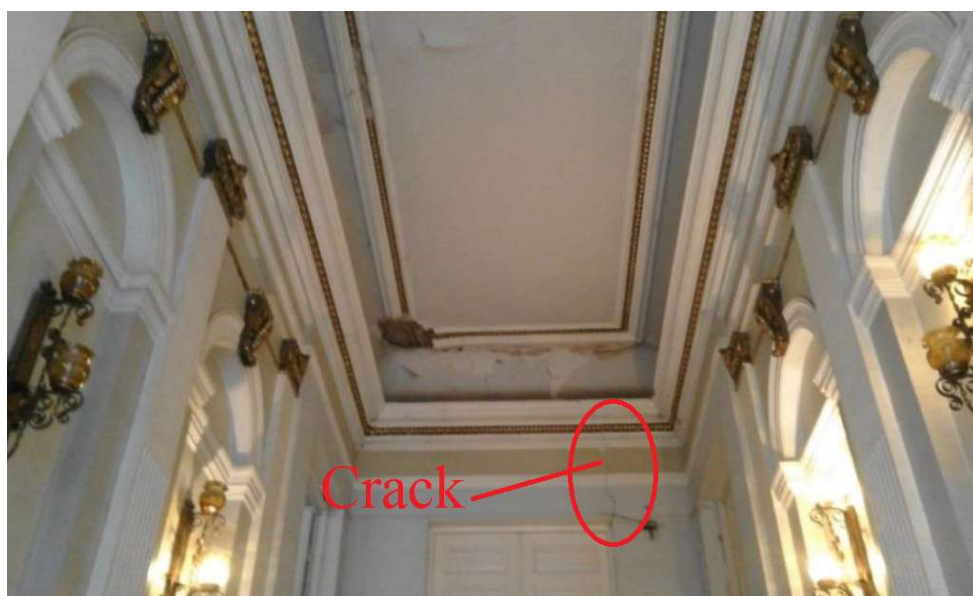
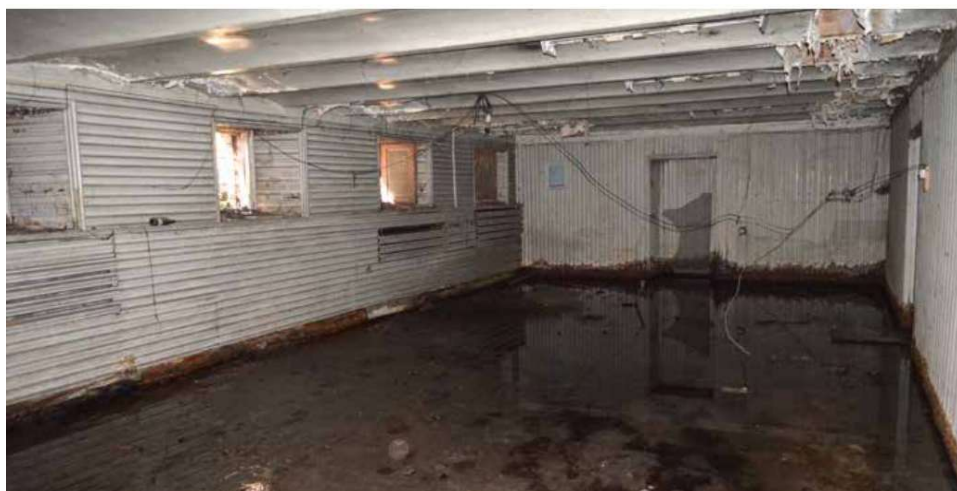
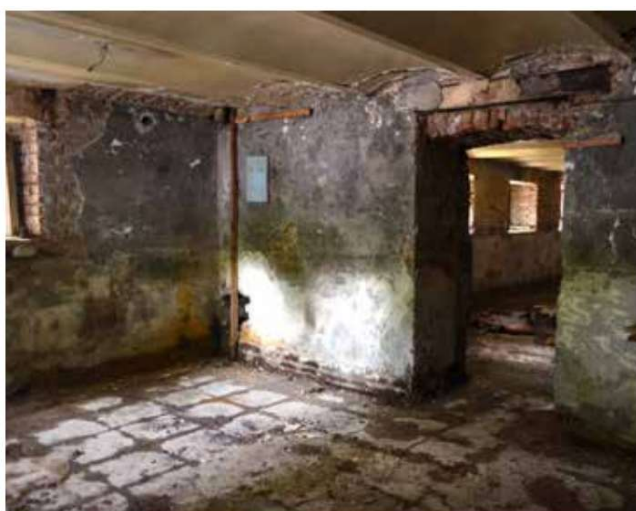
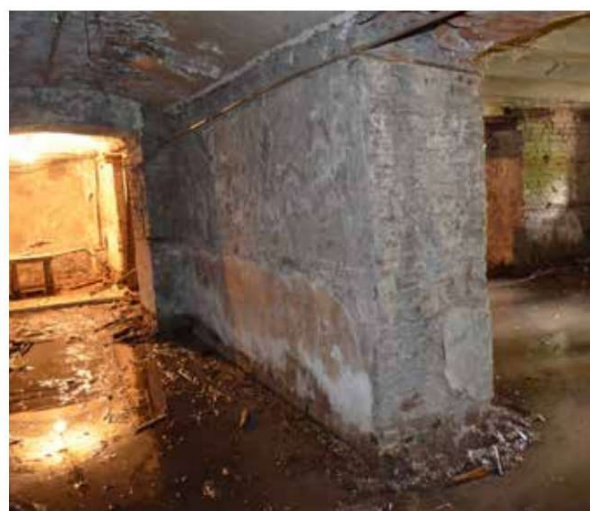
### Documentary Evidence of Damage to the State Silk Museum

The primary structural system is composed as follows: in the corridors of the basement and the first floor, stiffness at the intersections of four longitudinal and eight transverse axes is provided by arches supported on pilasters. Cracks of varying intensity and size are observed in most of the arches.

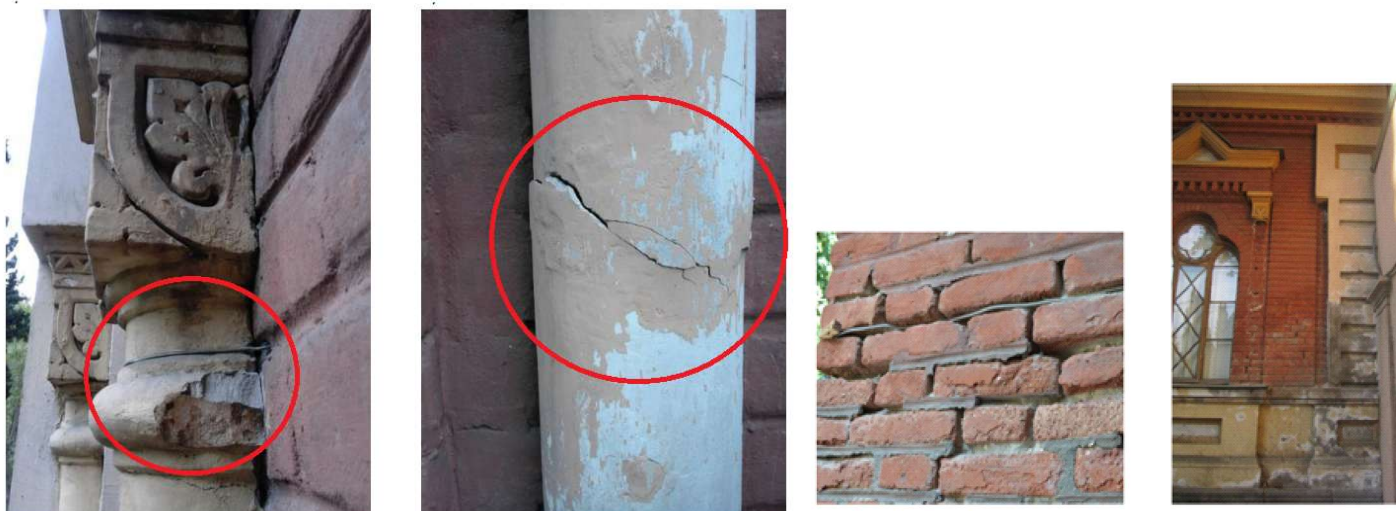
**Deteriorated plastered columns on the facade of the State Silk Museum**

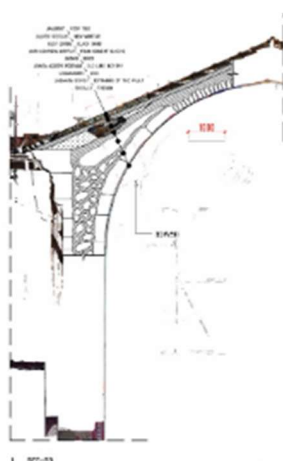
**Test Pit No. 3**

- **Location:** Test Pit No. 3 is located on the western roof of the northern arm, at the edge of the façade wall.
- **Preliminary Inspection:** A visual inspection of the roof revealed no surface damage. Likewise, the inspection carried out from the interior showed no delamination or detachment of the plaster layer beneath the paintings.
- **Video Endoscopic Survey:** Endoscopy revealed a 7-8 cm thick mortar layer beneath the glazed tiles, under which inert filler material is present.

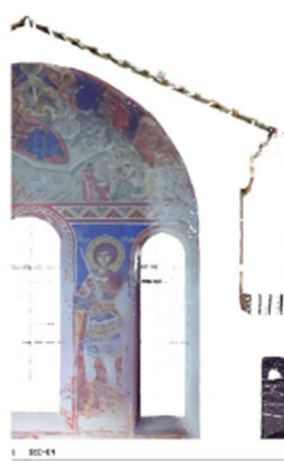
**Test Pit No. 4**

- **Location:** Test Pit No. 4 is located on the western roof of the SUTH arm, at the edge of the façade wall.
- **Preliminary Inspection:** A visual inspection of the roof revealed no surface damage. Likewise, the inspection carried out from the interior showed no delamination or detachment of the plaster layer beneath the paintings.
- **Video Endoscopic Survey:** Endoscopy revealed a 7-8 cm thick mortar layer beneath the glazed tiles, under which inert filler material is present.

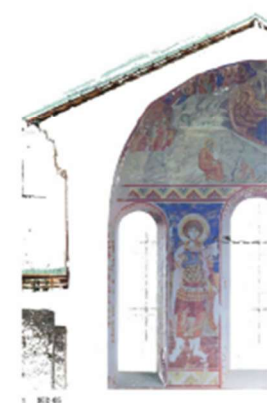
**Test Pit No. 5**

- **Location:** Test Pit No. 5 is located on the EASTERN roof of the SOUTH arm, at the edge of the façade wall.
- **Preliminary Inspection:** A visual inspection of the roof revealed no surface damage. Likewise, the inspection carried out from the interior showed no delamination or detachment of the plaster layer beneath the paintings.
- **Video Endoscopic Survey:** Endoscopy revealed a 9-10 cm thick mortar layer beneath the glazed tiles, under which inert filler material is present.

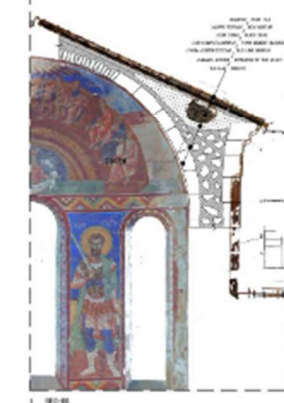
**Test Pit No. 6**

- **Location:** Test Pit No. 6 is located at the edge of the eastern roof of the northern arm, near the cornice.
- **Preliminary Inspection:** A visual inspection of the roof revealed no surface damage. Likewise, the inspection carried out from the interior showed no delamination or detachment in the plaster layer beneath the paintings.
- **Video Endoscopic Survey:** Endoscopy revealed a 10-15 cm 10-15 cm thick mortar layer beneath the glazed tiles, under which inert filler material is present.

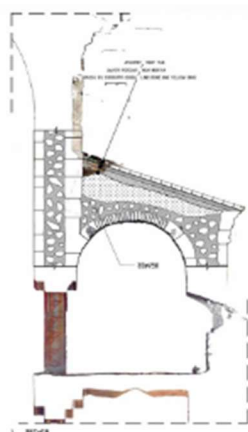
**Test Pit (Shurfi) No. 9**

- **Location:** Test pit No. 9 is located on the northern side of the Patronikon roof, near the pilaster adjacent to the load-bearing wall of the western arm of the church.
- **Preliminary Visual Inspection:** Visual examination revealed no surface or structural damage. Inspection from the interior also showed no structural deterioration. The vault and the walls in this area are not painted or plastered.
- **Endoscopic Investigation:** Endoscopy revealed a 15-20 cm thick mortar layer beneath the glazed roof tiles.

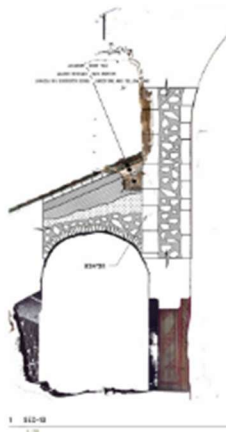
**Test Pit No. 10**

- **Location:** Test Pit No. 10 is arranged on the southern side, on the roof of the Patronikon, near the pilaster located at the load-bearing wall of the church's western arm.
- **Preliminary Inspection:** A visual inspection of the roof revealed no surface damage. Likewise, the inspection from the interior showed no delamination or detachment in the plaster layer beneath the paintings.
- **Video Endoscopic Survey:** Endoscopy revealed a 15-20 cm thick mortar layer beneath the glazed tiles, under which inert filler material is present.

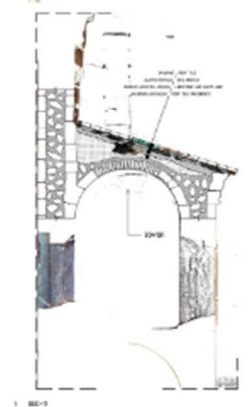
**Test Pit No. 11**

- **Location:** Test Pit No. 11 is arranged in the central section of Roof No. 11.
- **Preliminary Inspection:** A visual inspection of the roof revealed no surface damage. Likewise, the inspection from the interior showed that the vault and walls are neither painted nor plastered.
- **Video Endoscopic Survey:** Endoscopy revealed a 7-10 cm thick mortar layer beneath the glazed tiles, below which a change in material was observed, followed by a 20-26 cm thick second mortar layer. Beneath this second layer, a void was detected. A second endoscopic inspection—conducted closer to the back of the vault, in the lower cavity beneath the roof—showed that the material layers and mortar thicknesses corresponded to those seen in the first endoscopy; however, in this case, no void was detected.

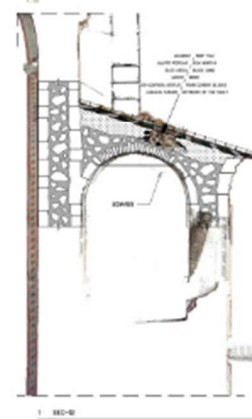
**Test Pit No. 12**

- **Location:** Test Pit No. 12 is located in the central part of Roof No. 12.
- **Preliminary Inspection:** A visual inspection of the roof revealed no surface damage. Likewise, the inspection from the interior showed no delamination or detachment in the plaster layer beneath the paintings.
- **Video Endoscopic Survey:** Endoscopy revealed a 7-10 cm thick mortar layer beneath the glazed tiles, under which inert filler material is present.

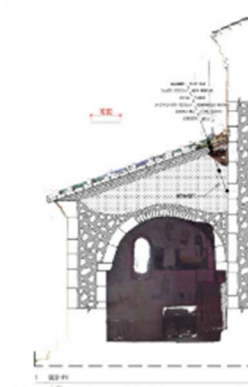
**Test Pit No. 14**

- **Location:** Test Pit No. 14 is located at the edge of Roof No. 14, near the gutter and the
- **Preliminary Inspection:** A visual inspection of the roof revealed no surface damage. Likewise, the inspection from the interior showed no delamination or detachment in the plaster layer beneath the paintings.
- **Video Endoscopic Survey:** Endoscopy revealed a 7-10 cm thick mortar layer beneath the glazed tiles, under which inert filler material is present.

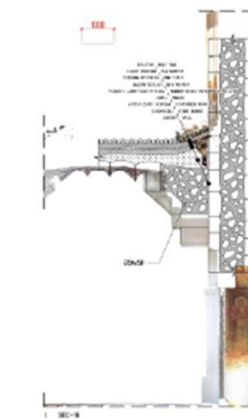
**Test Pit No. 16-17**

- **Location:** Test Pit No. 16 is located between Roofs No. 16 and No. 17, near the pilaster situated on the southern façade.
- **Preliminary Inspection:** A visual inspection of the roof revealed no surface damage. Likewise, the interior inspection showed no delamination or detachment in the plaster layer beneath the paintings.
- **Video Endoscopic Survey:** Endoscopy revealed a 7-10 cm thick mortar layer beneath the glazed tiles, under which inert filler material is present.

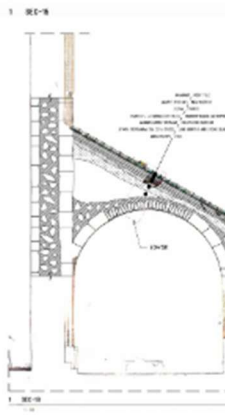
**Test Pit No. 19**

- **Location:** Test Pit No. 19 is located on the roof of the side chapel (ekvleri), positioned in the central part of the roof.
- **Preliminary Inspection:** A visual inspection of the roof revealed no surface damage. Likewise, the inspection from the interior showed no delamination or detachment in the plaster layer beneath the paintings.
- **Video Endoscopic Survey:** Endoscopy revealed a 25-28 cm thick mortar layer beneath the glazed tiles, under which inert filler material is present.

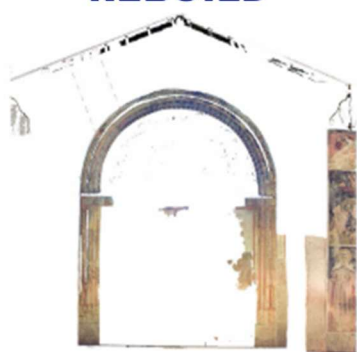
Test Pit No. 20 – 21

- **Location:** Test Pit №20 №21 is located above the northern gate.
- **Preliminary Inspection:** A visual inspection of the roof revealed no surface damage. Likewise, the inspection from the interior showed that the vault and walls are neither painted nor plastered.

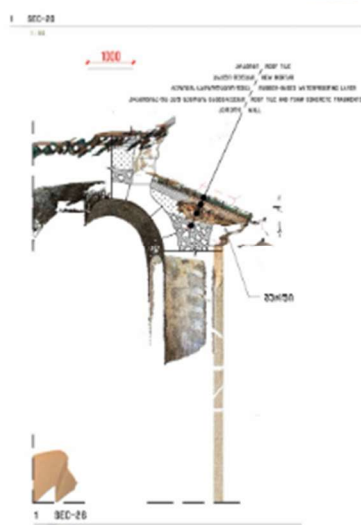
- **Location:** Test Pit No. 26 is arranged on the eastern side, above the small conch of the diaconicon.
- **Preliminary Inspection:** A visual inspection of the roof revealed no surface damage. Likewise, the inspection from the interior showed that the vault and walls are neither painted nor plastered.
- **Video Endoscopic Survey:** Endoscopy revealed a 10-13 cm 10-13 cm thick mortar layer beneath the glazed tiles, under which inert filler material is present.

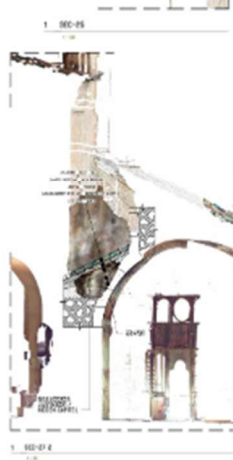
- **Location:** Test Pit No. 27 is located on the roof of the conch of the northern side chapel, adjacent to the façade wall of the church.
- **Preliminary Inspection:** A visual inspection of the roof revealed no surface damage. Likewise, the inspection from the interior showed no delamination or detachment in the plaster layer beneath the paintings.
- **Video Endoscopic Survey:** Endoscopy revealed a 2525-28 cm 28 cm thick mortar layer beneath the glazed tiles, under which inert filler material is present.
